Re: Environmental Review  
Seneca Nation Senior Housing Complex  
Alleghany Reservation, Salamanca, NY

# **SUBSURFACE SITE INVESTIGATION**

**SENIOR CITIZEN HOUSING COMPLEX  
44 SENECA STREET  
SALAMANCA, NEW YORK**

**SUBSURFACE SITE INVESTIGATION**  
**Seneca Nation Housing Authority**  
**44 Seneca Street**  
**Salamanca, New York**

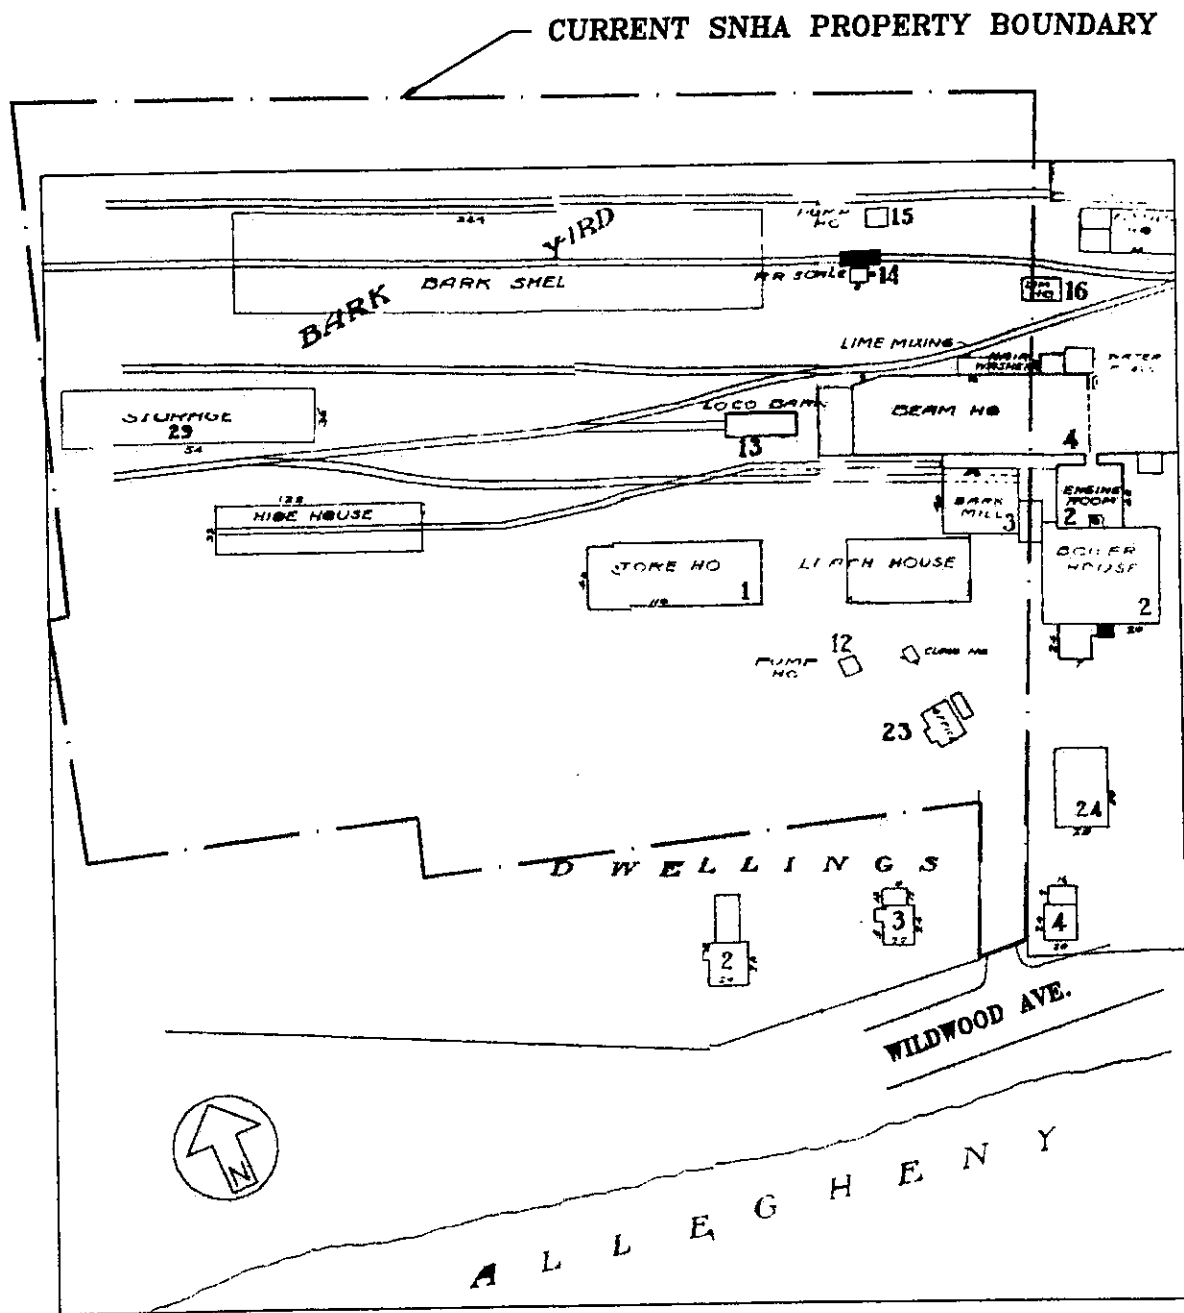
FIGURE 2

The site plan depicted in Figure 2 presents several interesting features including:

- The presence of a pump house in the southeast parking lot that coincides with an area that currently has experienced settling;
- The Northeast Wing of the building which has experienced subsidence of the floor slabs appears to have been built over what was called the "Beam House". Although research by S&A found no description of this building, it was likely a process building using "walking beam-type" agitation equipment to mix process liquids;

A review of Figure 2 and 3 shows that the Northeast Wing of the building was built in the location of the former "Beam House". Test pits were excavated around this wing and although quantities of demolition debris were encountered in TP-1, 2 and 3, no building foundations were discovered. Many pieces of iron including several old empty corroded 55 gallon drums were found in TP-1. From the soils excavated at these three test pits, it appeared that both gravel and demolition debris were used as backfill during the foundation excavations for the Senior Housing Complex in this area of the site.

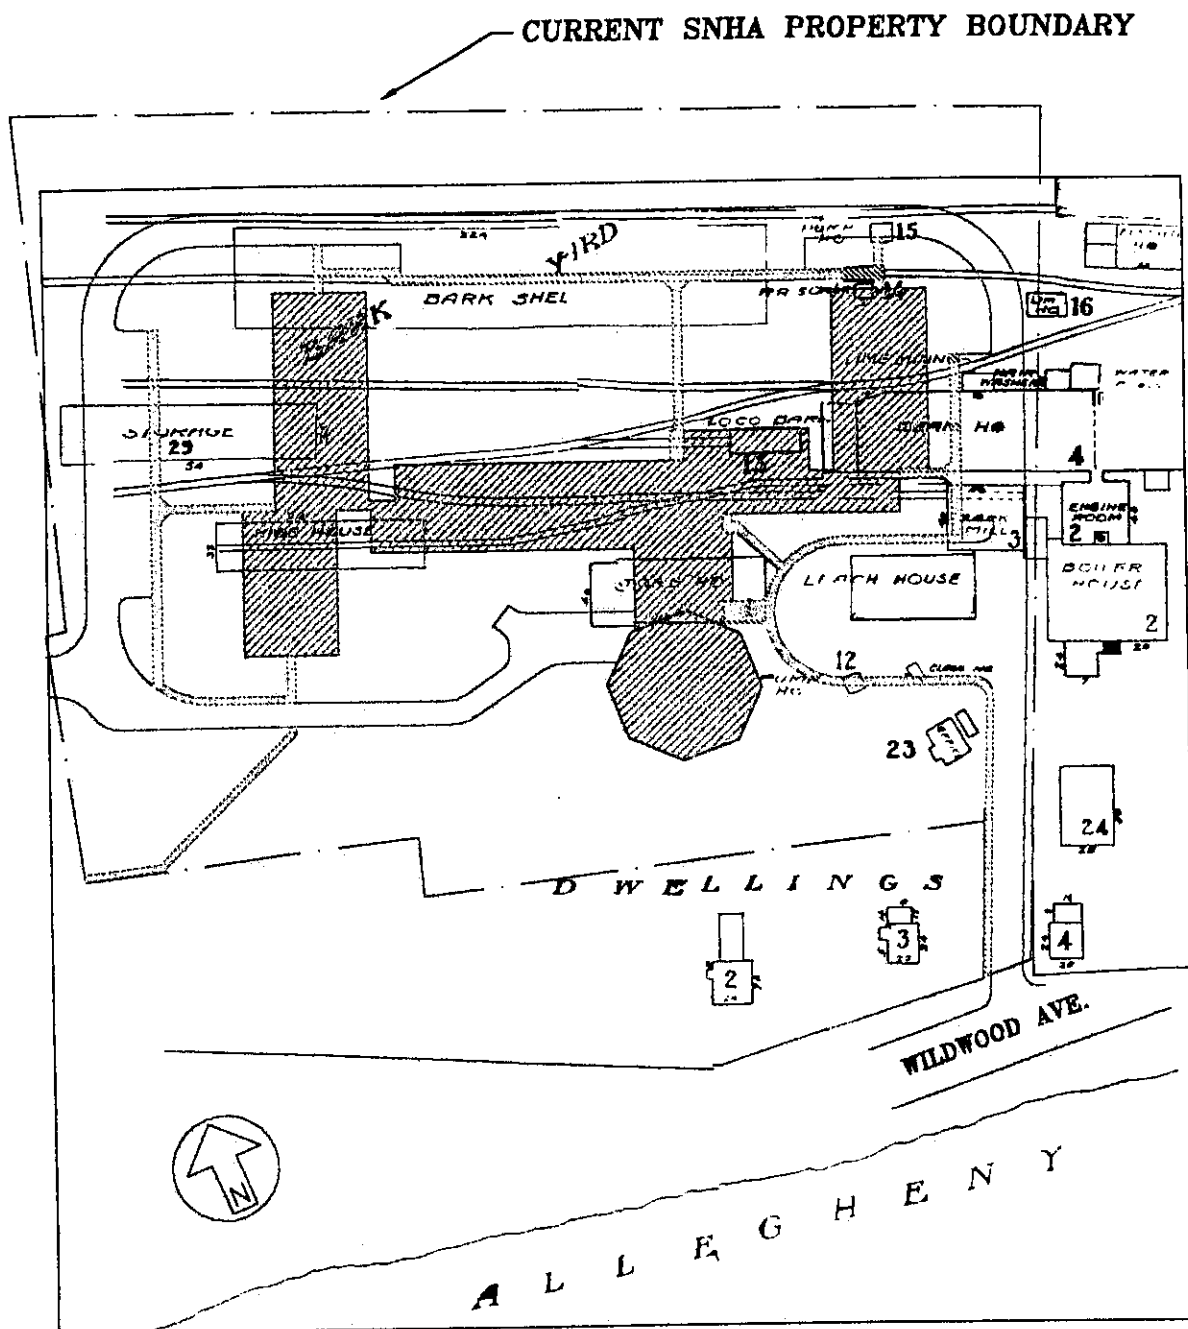
FIGURE 3

S&A has overlain the existing SNHA Senior Housing complex on a site plan produced by the U.S. Leather Company in 1909 and the overlay is shown in Figure 3. The red and blue lines in this figure represent the current SNHA site and the black lines show the buildings as they were in 1909. Although the 1909 site plan was in poor condition, this overlay clearly shows the current building was built in an area previously occupied by process buildings, rail sidings, and storage buildings. It should be noted that locations of the tannery buildings and their relation to the current structures as shown in this figure are approximate.

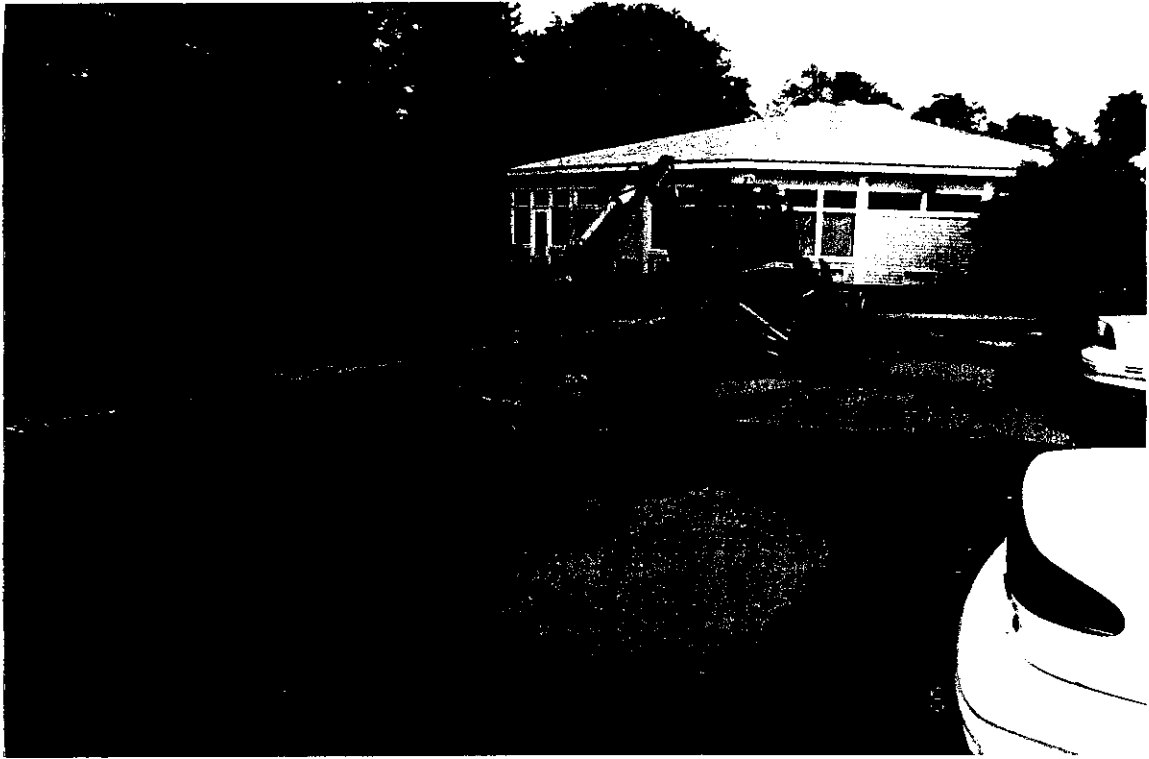
**FIGURE 5**

**TEST PIT-4 LOOKING SOUTHEAST**

**TEST PIT 4 SOIL PROFILE LOOKING SOUTHEAST**

TP-4 was located at the southeast side of the site in the parking area where a sink hole had developed (See Figure 5). Several inches of asphalt paving were encountered followed by approximately 6" of gravel base which was underlain by 6 feet of demolition debris. This demolition debris included a black compressible soil material (i.e., a pocket penetrometer indicated that the material had a bearing capacity of less than 0.25 tons per square foot).

This material appeared to be a loose mixture of soil and ash.

Also, a 12 inch thick brick masonry foundation was encountered at TP-4 six feet below grade. This foundation extended down at least an additional four feet (4') and was oriented along a North-South axis. As can be seen in Figure 2, two buildings previously existed in this area, a Clock House and a Pump House. When these structures were demolished, the area around them appears to have been filled with demolition debris. Over time the compressible portions of this material has apparently consolidated allowing a "sinkhole" to form at the surface. It is also possible, that the supply or drainage piping or other subsurface cavities from the tanning works may still be in-place allowing soil to migrate into these voids. At the completion of the test pit work, TP-4 was backfilled with excavated material to the level with the existing pavement. Currently the backfill material has subsided approximately 18 inches.

3. The areas with subsidence problems in the Southeast parking area and at the Northeast Dumpster pad need to be excavated to original undisturbed soils or to suitable fills. All demolition debris and other unsuitable material need to be removed and replaced with suitable fill such as bank run gravel. This material should be placed in 6" layers and compacted to 95% maximum dry density (ASTM D1557-91). The area should then be repaved.
